PHOTOGRAPHIC SURVEY OF THE LDEF MISSION

National Aeronautics and
Space Administration

NASA Special Publication 531
1996

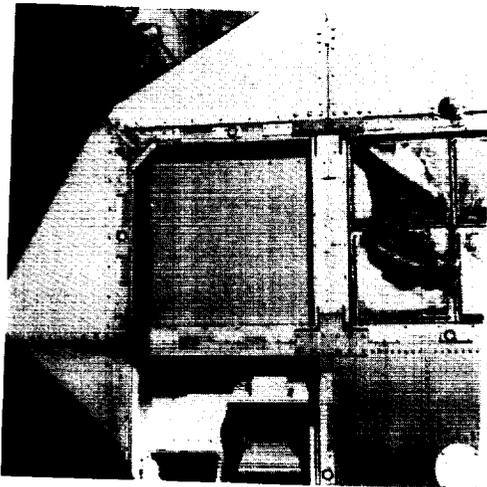
Figure 574 (In Flight). The paint dots on the experiment tray clamp blocks, which were originally white, show a tan stain that gets darker near the venting area of the end thermal panels. The stain also covers the top and left flanges of the experiment tray. To a lesser degree, the lower and right tray flanges are also covered with the stain. The vertical lines and the pinkish color of the debris panel are chromic anodize coating by-products and are not attributed to contamination or exposure to the space environment.

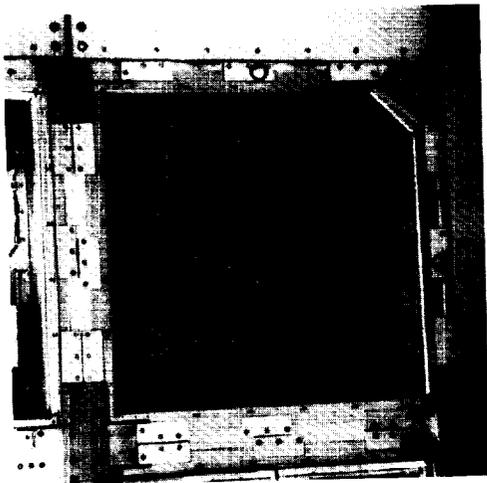
Figure 575
Photo No.: S32-S-293
Dup. Neg. No.: L92-21200
LISAR NO.: EL-1994-00077
Photo Credit: JSC
Photo Date: 1/22/90
Location: Shuttle Cargo Bay at Dryden
Subject: Postflight Survey of Tray H5

Figure 575 (Postflight). This photograph was taken from the cargo bay access hatch of the orbiter during postlanding operations at the Dryden Flight Research Center. Note the discolorations on the structure of the LDEF, tray flanges, and tray clamp white dots and the variation with proximity to the thermal panel vents. The discolorations on the tray sidewalls appear to be fingerprints enhanced by the brown stain. Light discolorations are located near the lower side of the debris panel. The horizontal lines and the pinkish tint of the debris panel are chromic anodize coating by-products and are not attributed to contamination or exposure to the space environment. Darker discolorations on the debris panel, similar to water marks, are apparent in the photograph.

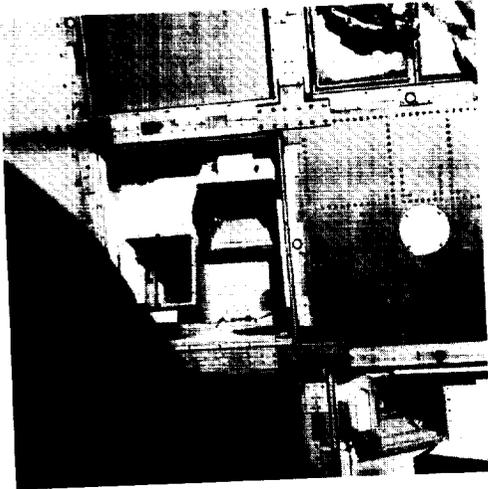
Figure 578
Photo No.: S32-75-063
Dup. Neg. No.: L90-10369
LISAR NO.: EL-1994-00674
Photo Credit: JSC
Photo Date: 1/12/90
Location: In Flight
Subject: In-Flight Survey of Tray H6

Figure 578 (In Flight). A shadow of the shuttle obscures part of the tray. A very light contamination stain is present on the experiment tray flanges and on most of the visible structure. An exception is a much darker stain on the structure adjacent to thermal panels that provided venting for the interior of the LDEF. The white thermal control paint now varies from off-white to a dark brown. Localized dark brown areas in the tray are visible. A beryllium copper collector foil is clearly visible in the lower left canister housing as are the baffles. Light from the fine wire mesh grid is reflected near the top of the canister housing. Because of an experiment system malfunction, the canister collector foils that are visible were exposed for the total mission.

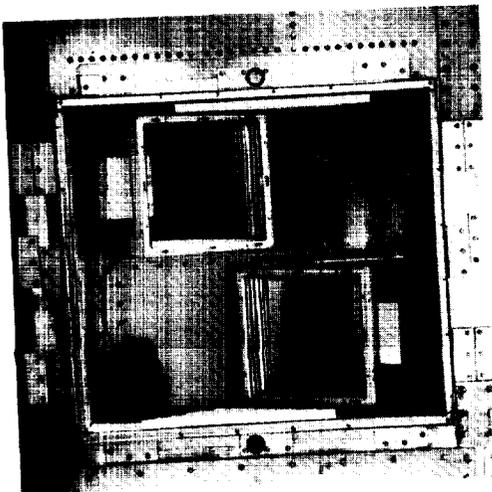
Figure 579
Photo No.: S32(S)-290
Dup. Neg. No.: L92-21197
LISAR NO.: EL-1994-00076
Photo Credit: JSC
Photo Date: 1/22/90
Location: Shuttle Cargo Bay at Dryden
Subject: Postflight Survey of Tray H6

Figure 579 (Postflight). This photograph was taken from the cargo bay access hatch of the orbiter during postlanding operations at the Dryden Flight Research Center. Note the discolorations on the structure of the LDEF, tray flanges, and tray clamp white dots and the variation of discoloration with proximity to the thermal panel vents. The darker appearance of the tray interior is probably due to lighting. A beryllium copper collector foil is clearly visible within the canister housings as are the baffles. Reflected light from the fine wire mesh grid is visible near the top of the canister housing.

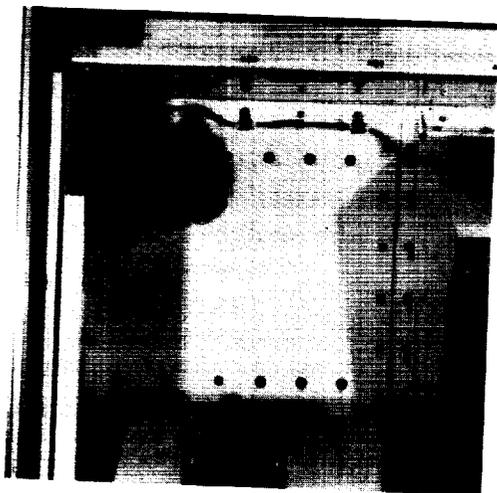
Figure 581
Photo No.: KSC-390C-1641.04
Dup. Neg. No.: L91-11829
LISAR NO.: EL-1994-00051
Photo Credit: KSC
Photo Date: 3/6/90
Location: KSC SAEF II
Subject: Postflight Detail of Upper Left of Tray H6

Figure 581 (Postflight). This photograph is of the upper left one-fourth of the tray. Note the extreme dark brown discoloration around the grid voltage plug in the corner of the tray.

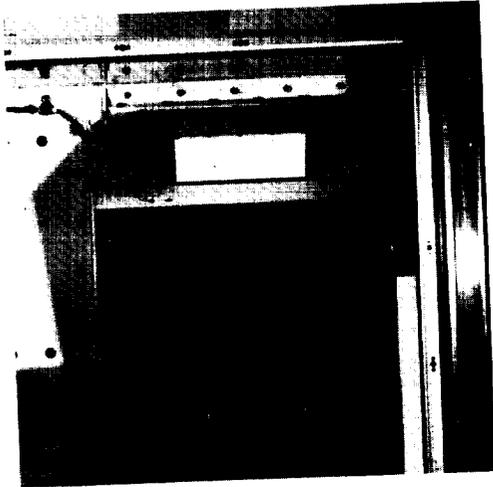
Figure 582
Photo No.: KSC-390C-1641.05
Dup. Neg. No.: L91-11830
LISAR NO.: EL-1994-00052
Photo Credit: KSC
Photo Date: 3/6/90
Location: KSC SAEF II
Subject: Postflight Detail of Upper Right of Tray H6

Figure 582 (Postflight). This photograph is of the upper right one-fourth of the tray. Some dark contamination is visible below the canister. Some shadows are caused by photographic lighting. The cover has been installed on the canister housing to protect the space-exposed hardware.

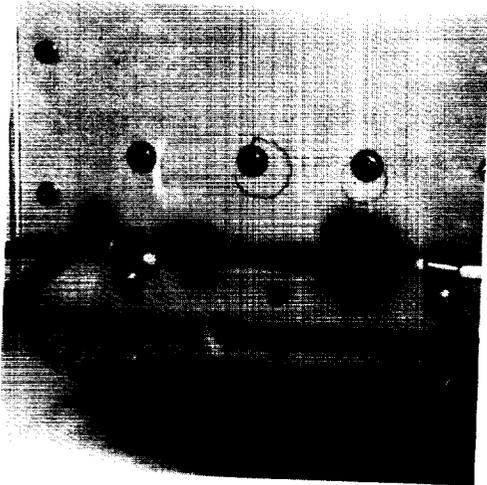
Figure 585
Photo No.: KSC-390C-1642.05
Dup. Neg. No.: L91-11839
LISAR NO.: EL-1994-00261
Photo Credit: KSC
Photo Date: 3/6/90
Location: KSC SAEF II
Subject: Postflight Detail of Lower Right Corner of
Tray H6

Figure 585 (Postflight). This close-up photograph is of the lower right corner of the tray. Note the localized extreme brown discoloration around the electrical cable wraps. There is a reflection of the cable in the tray sidewall.

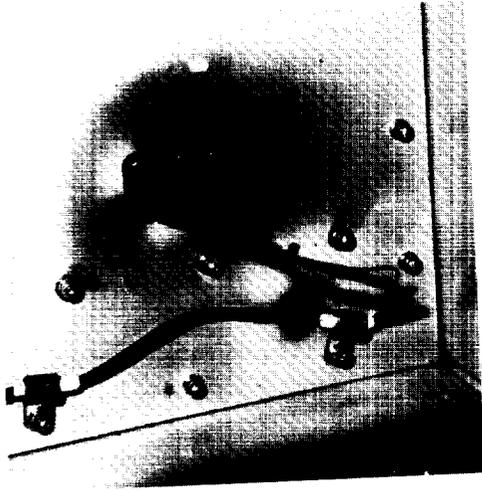
Figure 586
Photo No.: KSC-390C-1642.07
Dup. Neg. No.: L91-11841
LISAR NO.: EL-1994-00276
Photo Credit: KSC
Photo Date: 3/6/90
Location: KSC SAEF II
Subject: Postflight Detail of Lower Right Corner of
Tray H6

Figure 586 (Postflight). This close-up photograph is of the lower right corner of the tray. Note the brown discoloration around the grid voltage plug and around the cable wraps.

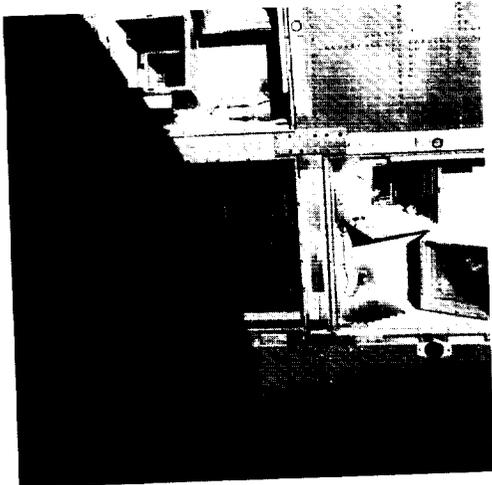
Figure 592
Photo No. S32-75-062
Dup. Neg. No.: L90-10368
LISAR NO.: EL-1994-00673
Photo Credit: JSC
Photo Date: 1/12/90
Location: In Flight
Subject: In-Flight Survey of Tray H7

Figure 592 (In Flight). A shadow cast by the orbiter covers most of the left half of the tray, which contains the active part of the experiment. The experiment appears to be without physical damage. Even in the shadow, a light tan discoloration is visible on the left and lower flanges of the experiment tray. A darker stain has discolored the originally white paint dots on the experiment tray clamp blocks. Dark brown stains on the structure of the LDEF are visible in areas adjacent to the edge of thermal end panels that were designed to facilitate venting of the interior.

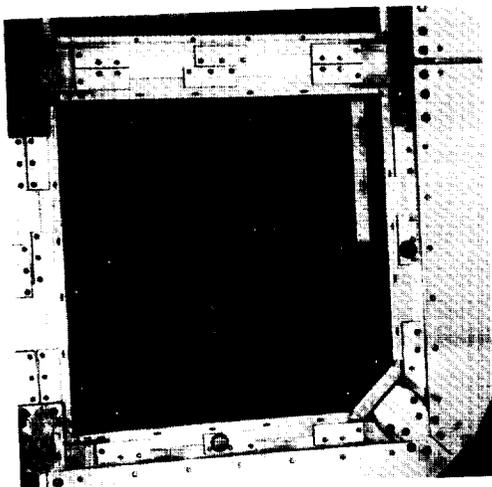
Figure 593
Photo No.: S32(S)-288
Dup. Neg. No.: L92-21195
LISAR NO.: EL-1994-00075
Photo Credit: JSC
Photo Date: 1/22/90
Location: Shuttle Cargo Bay at Dryden
Subject: Postflight Survey of Tray H7

Figure 593 (Postflight). The experiment appears to have no physical damage. This photograph was taken from the cargo bay access hatch of the orbiter during postlanding operations at the Dryden Flight Research Center. Note the discolorations on the structure of the LDEF, the tray flanges, and the tray clamp white dots and the variation of discoloration with proximity to the thermal panel vents. The black thermal coating on the passive part of the experiment appears unchanged, while the black thermal coating on the active part of the experiment appears dark gray. The surfaces of the Kapton film specimens of the passive experiment appear to have changed from specular to diffuse after exposure to the space environment.

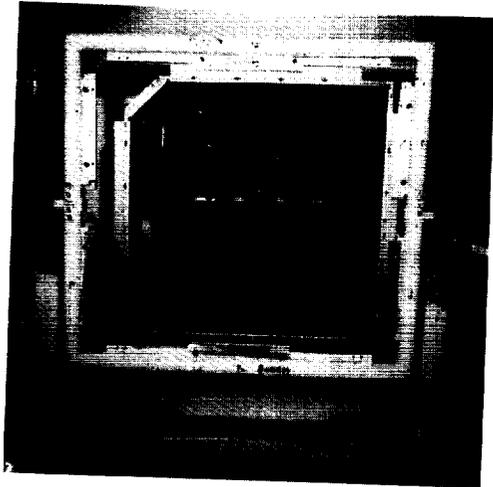
Figure 594
Photo No.: KSC-390C-1990.01
Dup. Neg. No.: L91-15659
LISAR NO.: EL-1994-00295
Photo Credit: KSC
Photo Date: 3/15/90
Location: KSC SAEF II
Subject: Postflight Survey of Tray H7

Figure 594 (Postflight). Experiment AO133 appears to have no physical damage. A light tan discoloration is visible on the left and lower flanges of the experiment tray and also on the unpainted aluminum filler to the left of the passive part of the experiment. A darker stain has discolored the lower corners of the tray structure. The black thermal coating on the active part of the experiment has changed from flat black to dark gray. The coating on the passive part of the experiment appears less degraded. The exposed surfaces of the Kapton film specimens in both the active and passive parts of the experiment appear to have changed from specular to diffuse because of exposure to the space environment.

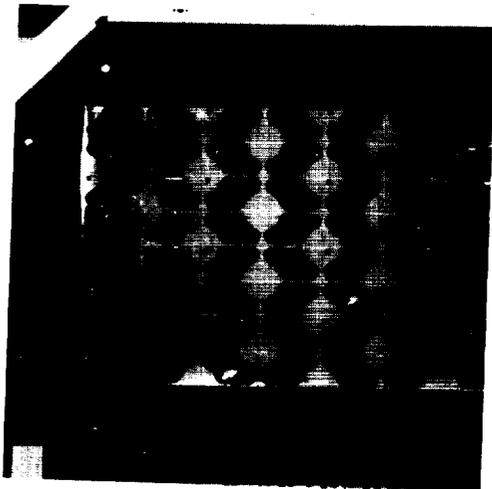
Figure 595
Photo No.: KSC-390C-1990.03
Dup. Neg. No.: L91-15642
LISAR NO.: EL-1994-00409
Photo Credit: KSC
Photo Date: 3/15/90
Location: KSC SAEF II
Subject: Postflight Detail of Upper Left of Tray H7

Figure 595 (Postflight). This photograph is of the upper left one-fourth of the tray. The experiment is intact, but the surface appears lighter than in preflight conditions. Light reflections from some underlying surfaces are visible.

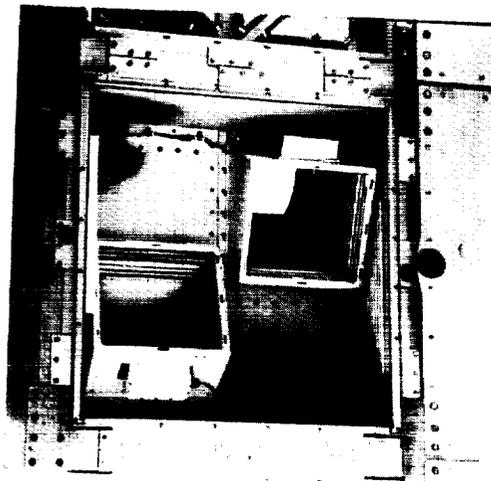
Figure 601
Photo No.: S32(S)-286
Dup. Neg. No.: L92-21193
LISAR NO.: EL-1994-00074
Photo Credit: JSC
Photo Date: 1/22/90
Location: Shuttle Cargo Bay at Dryden
Subject: Postflight Survey of Tray H9

Figure 601 (Postflight). This photograph was taken from the cargo bay access hatch of the orbiter during postlanding operations at the Dryden Flight Research Center. Note the discolorations on the structure of the LDEF, tray flanges, and tray clamp white dots and the variation of discoloration with proximity to the thermal panel vents. The color of the white thermal control paint now varies from off-white to dark brown with areas of concentrated discoloration. A beryllium copper collector foil is clearly visible in the upper right canister housing as are the baffles. Reflected light from the fine wire mesh grid is visible near the top of the canister housing.

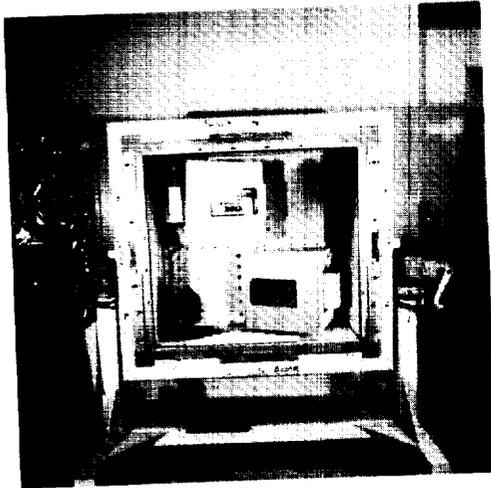
Figure 602
Photo No.: KSC-390C-1636.10
Dup. Neg. No.: L91-11881
LISAR NO.: EL-1994-00214
Photo Credit: KSC
Photo Date: 3/6/90
Location: KSC SAEF II
Subject: Postflight Survey of Tray H9

Figure 602 (Postflight). The brown stains are still very prominent and appear to be the same as in the in-flight photograph. The openings in the baseplate for the grid voltage cable connector mounts are thought to be the source of the darker brown stains around the connectors. The covers were installed on the canister housings to protect the space-exposed hardware. The contamination stain provides an outline of tray clamp block locations on the tray flanges.

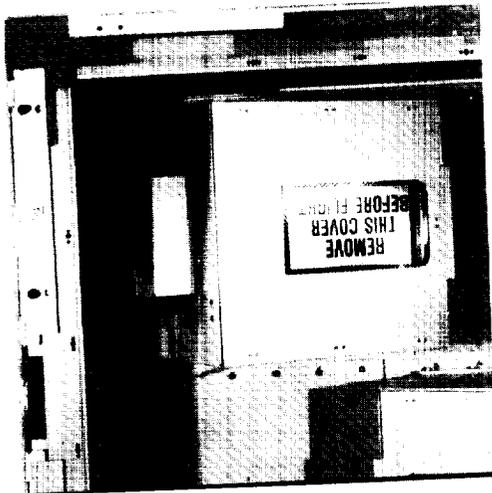
Figure 603
Photo No.: KSC-390C-1637.01
Dup. Neg. No.: L91-11912
LISAR NO.: EL-1994-00656
Photo Credit: KSC
Photo Date: 3/6/90
Location: KSC SAEF II
Subject: Postflight Detail of Upper Left of Tray H9

Figure 603 (Postflight). This photograph is of the upper left one-fourth of the tray. Note the discoloration on the tray around the canister. The cover was installed on the canister housing to protect the space-exposed hardware.

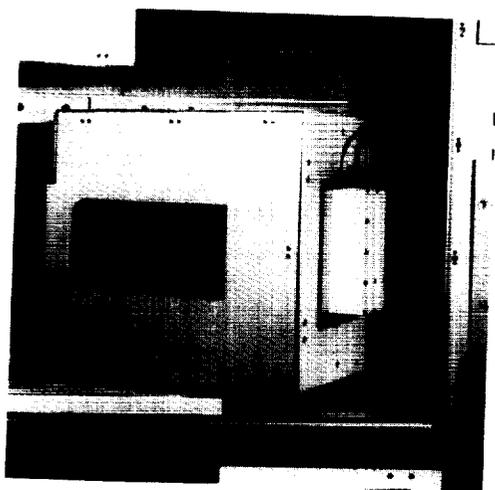
Figure 605
Photo No.: KSC-390C-1637.03
Dup. Neg. No.: L91-11914
LISAR NO.: EL-1994-00696
Photo Credit: KSC
Photo Date: 3/6/90
Location: KSC SAEF II
Subject: Postflight Detail of Lower Right of
Tray H9

Figure 605 (Postflight). This photograph is of the lower right one-fourth of the tray. Note the discoloration on the tray around the canister. Some photographic light shadows are present. The cover was installed on the canister housing to protect the space-exposed hardware.

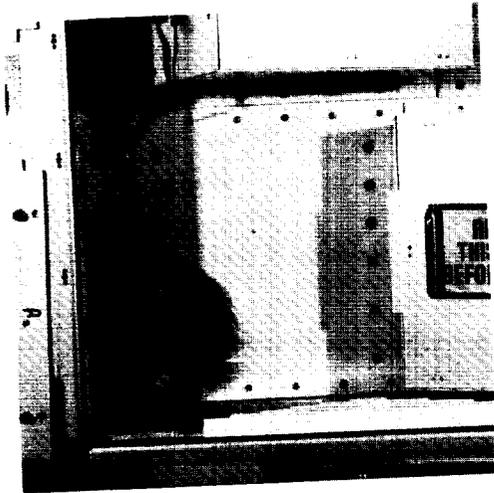
Figure 606 (Postflight). This photograph is of the lower left one-fourth of the tray. Note the extreme brown discoloration on the tray around the grid voltage lead and plug. There are reflections of the lead in the bottom of the tray. The cover was installed on the canister housing to protect the space-exposed hardware.

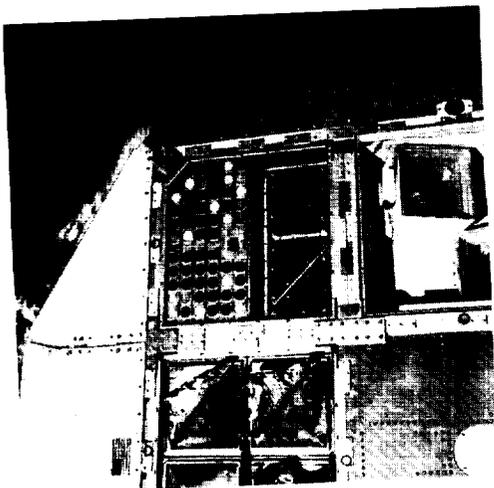
Figure 608
Photo No.: S32-75-060
Dup. Neg. No.: L90-10366
LISAR NO.: EL-1994-00671
Photo Credit: JSC
Photo Date: 1/12/90
Location: In Flight
Subject: In-Flight Survey of Tray H11

Figure 608 (In Flight). There is a brown stain on the tray structure and most aluminum surfaces of experiments. Note the discolorations on the structure of the LDEF, tray flanges, and tray clamp white dots and the variation of discoloration with proximity to the thermal panel vents. The colors in the mirrorlike surface of the detectors are a reflection of the sky and clouds. The dark spot on the detector in the third row from the top seems to be a flaw in the photograph since no damage was found in a postflight inspection.

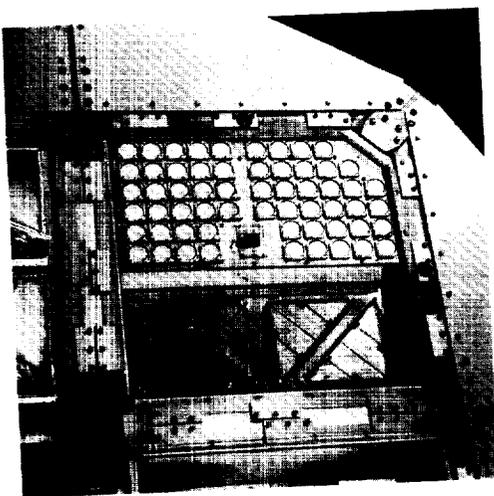
Figure 609
Photo No.: S32(S)-284
Dup. Neg. No.: L92-21191
LISAR NO.: EL-1994-00073
Photo Credit: JSC
Photo Date: 1/22/90
Location: Shuttle Cargo Bay at Dryden
Subject: Postflight Survey of Tray H11

Figure 609 (Postflight). This postlanding photograph was taken from the cargo bay access hatch of the orbiter during postlanding operations at the Dryden Flight Research Center. Note the discolorations on the structure of the LDEF, tray flanges, and tray clamp white dots and the variation of discoloration with proximity to the thermal panel vents. The colors in the mirrorlike surface of the detectors are a reflection of the cargo bay liner of the orbiter.

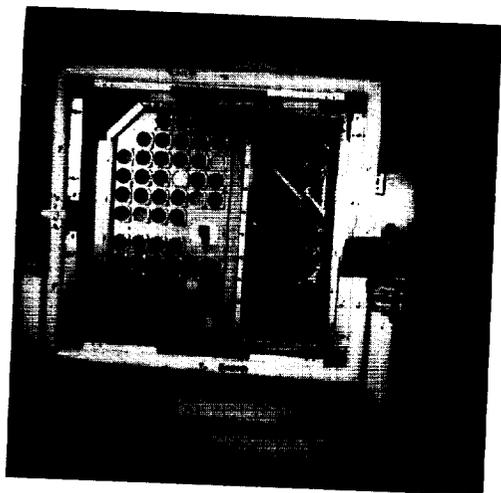
Figure 610
Photo No.: KSC-390C-2065.07
Dup. Neg. No.: L91-15678
LISAR NO.: EL-1994-00297
Photo Credit: KSC
Photo Date: 3/19/90
Location: KSC SAEF II
Subject: Postflight Survey of Tray H11

Figure 610 (Postflight). Both experiments appear intact. The colors in the mirrorlike surface of the detectors are reflections of the surrounding area. A dark spot on a detector in the third row from the top in the in-flight photograph was not found in a postflight inspection.

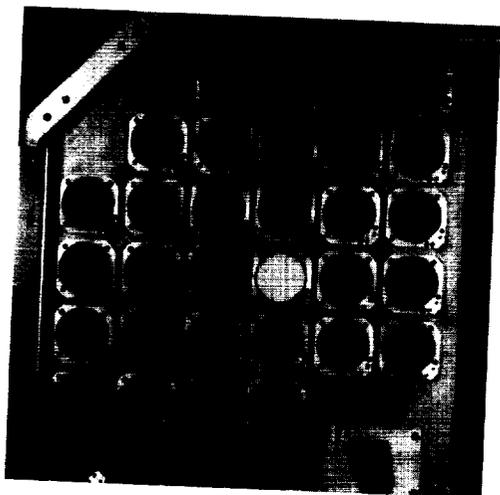
Figure 611
Photo No.: KSC-390C-2065.08
Dup. Neg. No.: L91-15679
LISAR NO.: EL-1994-00464
Photo Credit: KSC
Photo Date: 3/19/90
Location: KSC SAEF II
Subject: Postflight Detail of Upper Left of Tray H11

Figure 611 (Postflight). This photograph is of the upper left one-fourth of the tray. The tray flanges, the sensor holders, and the base mounting plate all have a brown stain. There is a brown stain on the upper right edge of the sensor surfaces. Surroundings are reflected in the mirrorlike surfaces of the detectors.

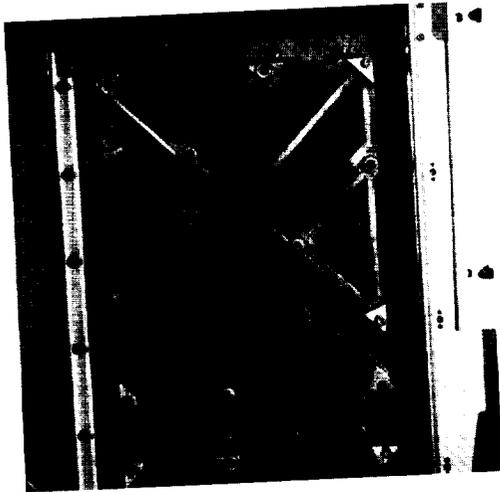
Figure 612
Photo No.: KSC-390C-2065.09
Dup. Neg. No.: L91-15680
LISAR NO.: EL-1994-00465
Photo Credit: KSC
Photo Date: 3/19/90
Location: KSC SAEF II
Subject: Postflight Detail of Upper Right of
Tray H11

Figure 612 (Postflight). This photograph is of the upper right one-fourth of the tray. The die-cast aluminum frames, fasteners, thermal isolation plate, and polished aluminum stop plate are moderately coated with a brown stain. The stain appears more concentrated in vicinities near adhesive bond joints.

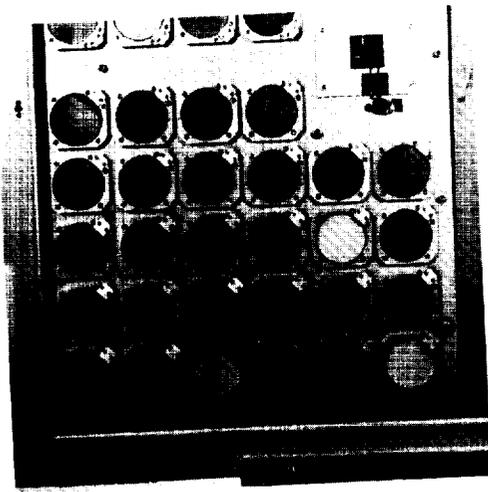
Figure 613
Photo No.: KSC-390C-2065.10
Dup. Neg. No.: L91-15681
LISAR NO.: EL-1994-00466
Photo Credit: KSC
Photo Date: 3/19/90
Location: KSC SAEF II
Subject: Postflight Detail of Lower Left of Tray H11

Figure 613 (Postflight). This photograph is of the lower left one-fourth of the tray. The tray flanges, the sensor holders, and the base mounting plate all have a brown stain. There is a brown stain on the upper right edge of the sensor surfaces. Surroundings are reflected in the mirrorlike surfaces of the detectors.

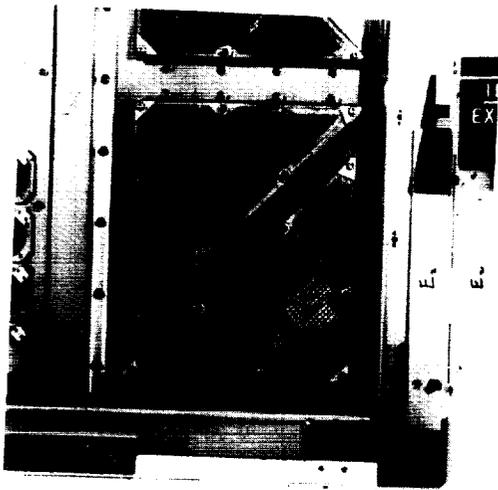
Figure 614
Photo No.: KSC-390C-2065.11
Dup. Neg. No.: L91-15682
LISAR NO.: EL-1994-00467
Photo Credit: KSC
Photo Date: 3/19/90
Location: KSC SAEF II
Subject: Postflight Detail of Lower Right of
Tray H11

Figure 614 (Postflight). This photograph is of the lower right one-fourth of the tray. The die-cast aluminum frames, fasteners, thermal isolation plate, and polished aluminum stop plate seem to be moderately coated with a brown stain. The stain appears to be more concentrated in vicinities near adhesive bond joints. There are photographic light reflections in the foil sensor surfaces.

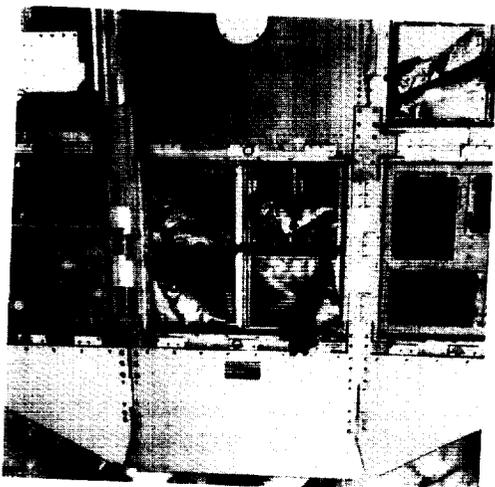
Figure 616
Photo No.: S32-75-067
Dup. Neg. No.: L90-10373
LISAR NO.: EL-1994-00676
Photo Credit: JSC
Photo Date: 1/12/90
Location: In Flight
Subject: In-Flight Survey of Tray H12

Figure 616 (In Flight). The multilayer thermal insulation blankets have extensive damage. The outside blanket surfaces that were originally white are now coated with a glossy dark brown stain. A light coating of the stain is on the tray flange adjacent to the American flag. Note the discolorations on the structure of the LDEF, tray flanges, and tray clamp white dots and the variation of discoloration with proximity to the thermal panel vents.

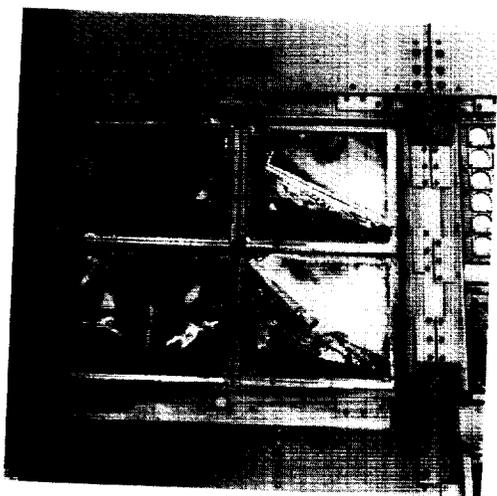
Figure 617
Photo No.: S32(S)-283
Dup. Neg. No.: L92-21190
LISAR NO.: EL-1994-00072
Photo Credit: JSC
Photo Date: 1/22/90
Location: Shuttle Cargo Bay at Dryden
Subject: Postflight Survey of Tray H12

Figure 617 (Postflight). This photograph of experiment M0001 was taken from the cargo bay access hatch of the orbiter during postlanding operations at the Dryden Flight Research Center. The photograph shows the extensive damage to the multilayer thermal blankets. The loose blankets appear to be more tightly rolled than in the in-flight photograph. The outside blanket surfaces that were originally painted white are now coated with a glossy dark brown stain.

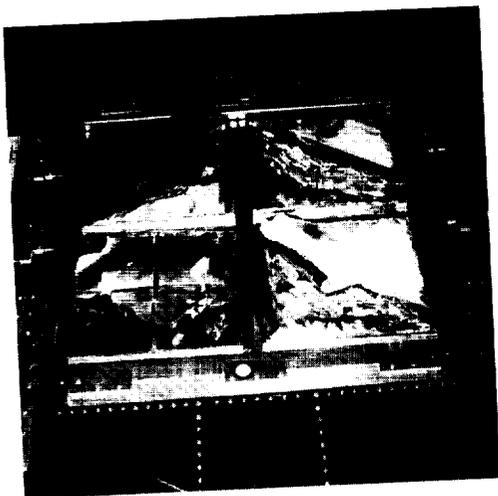
Figure 618
Photo No.: L90-1796
LISAR NO.: EL-1994-00380
Photo Credit: LaRC
Photo Date: 2/6/90
Location: KSC SAEF II
Subject: Postflight Survey of Tray H12

Figure 618 (Postflight). The postflight photograph shows the four experiment modules with multilayer thermal blankets that are severely degraded. Paint on the top layer, previously white, is now a glossy soft brown or tan. The thermal blankets apparently shrunk in flight, thus causing them to detach from the frame along two sides. The tape used to attach the blanket to the structure failed in tension across the width of the tape, thus leaving tape on both the frame and the top layer of the thermal blanket. The thermal blankets on the three large modules have curled to expose the top Lexan layer of the detector stack beneath. The curled thermal blankets that protected the four smaller modules in the lower left now expose the 5-mil aluminized Kapton film pressure covers beneath. The damaged thermal blankets on the right side of the photograph reveal representative cross sections of the multilayer thermal blankets.

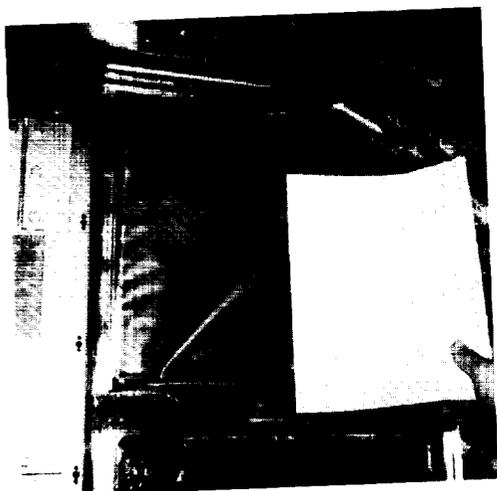
Figure 623
Photo No.: KSC-390C-829.02
Dup. Neg. No.: L91-15557
LISAR NO.: EL-1994-00283
Photo Credit: KSC
Photo Date: 2/6/90
Location: KSC SAEF II
Subject: Postflight Detail of Tray H12

Figure 623 (Postflight). This photograph shows a white card for comparison with the discolored thermal covers.

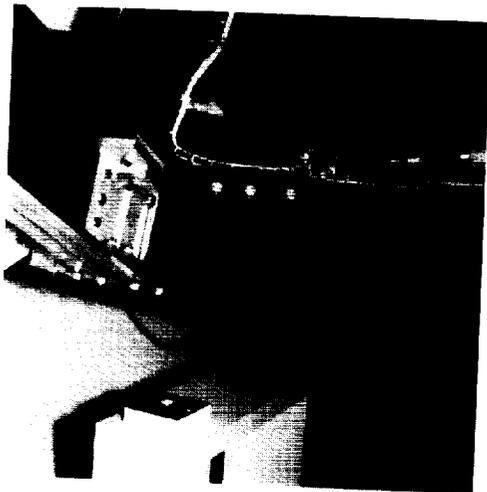
Figure 624
Photo No.: KSC-390C-2951.10
Dup. Neg. No.: L92-20490
LISAR NO.: EL-1994-00608
Photo Credit: KSC
Photo Date: 4/8/90
Location: SAEF II
Subject: Postflight Detail of Longeron A Between Rows 12 and 1

Figure 624 (Postflight). This photograph shows longeron A between rows 12 and 1 with the Earth-facing end to the left. The side of tray A12 was adjacent to this longeron. Little if any contamination on the longeron is visible. Note the discoloration on the intercostal to the left. The edge of the thermal panel location is marked by a line of concentrated brown discoloration. This discoloration was the effect of internal venting. The area covered by the tray flange contrasts with the unshielded area of the intercostal.

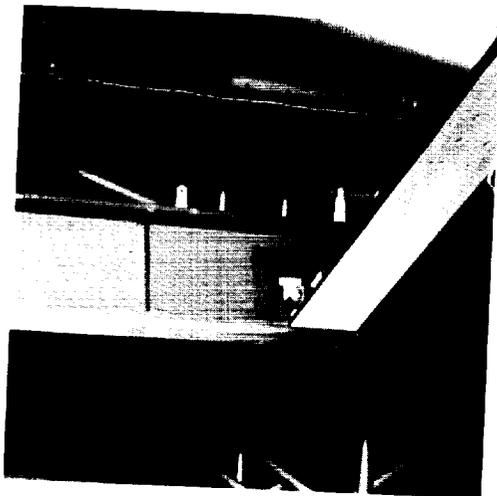
Figure 661
Photo No.: KSC-390C-3459.11
Dup. Neg. No.: L92-19144
LISAR NO.: EL-1994-00552
Photo Credit: KSC
Photo Date: 4/20/90
Location: SAEF II
Subject: Postflight Detail of Right Side of Bay C

Figure 661 (Postflight). Tray C6 was adjacent to this part (right intercostal of bay C) of longeron F. There is a significant and well-defined pattern of discoloration with distinctly different shadings near the right intercostal. Note the sharp cutoff of the discoloration just to the left of the intercostal.

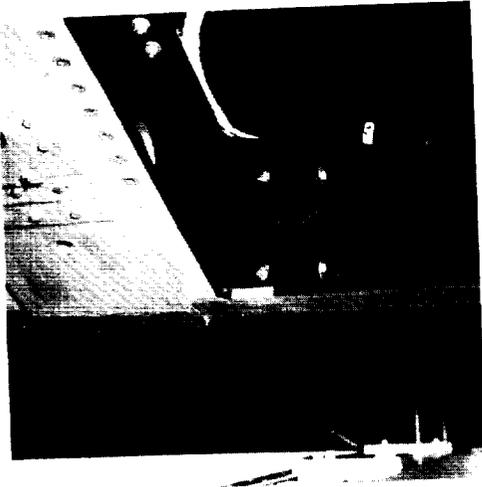
Figure 662
Photo No.: KSC-390C-3460.02
Dup. Neg. No.: L92-20027
LISAR NO.: EL-1994-00553
Photo Credit: KSC
Photo Date: 4/20/90
Location: SAEF II
Subject: Postflight Detail of Left Side of Bay C

Figure 662 (Postflight). Tray C6 was adjacent to this part (center ring of bay C) of long-eron F. There is a faint indication of a pattern of discoloration near the center ring.

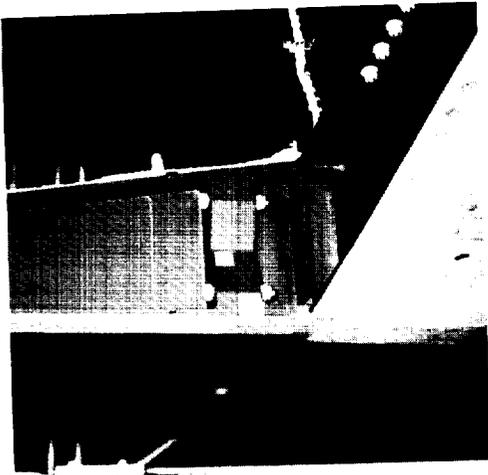
Figure 663
Photo No.: KSC-390C-3460.03
Dup. Neg. No.: L92-20028
LISAR NO.: EL-1994-00554
Photo Credit: KSC
Photo Date: 4/20/90
Location: SAEF II
Subject: Postflight Detail of Right Side of Bay D

Figure 663 (Postflight). Tray D6 was adjacent to this (center ring of bay D) part of long-eron F. There is a small pattern of discoloration near the center ring.

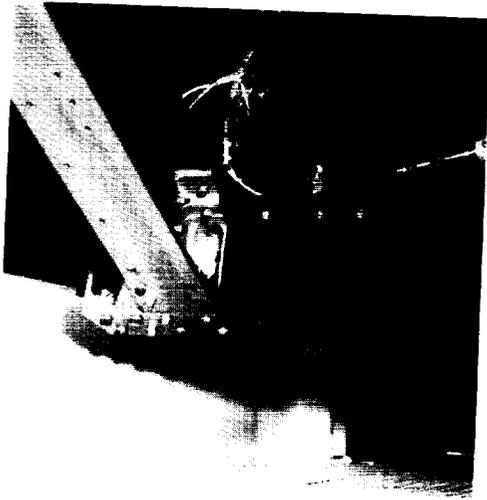
Figure 668
Photo No.: KSC-390C-3460.11
Dup. Neg. No.: L92-20036
LISAR NO.: EL-1994-00580
Photo Credit: KSC
Photo Date: 4/20/90
Location: SAEF II
Subject: Postflight Detail of Left Side of Bay F

Figure 668 (Postflight). Tray F6 was adjacent to this part (left intercostal of bay F) of long-eron F. There is a small but distinct pattern of discoloration near the left intercostal.

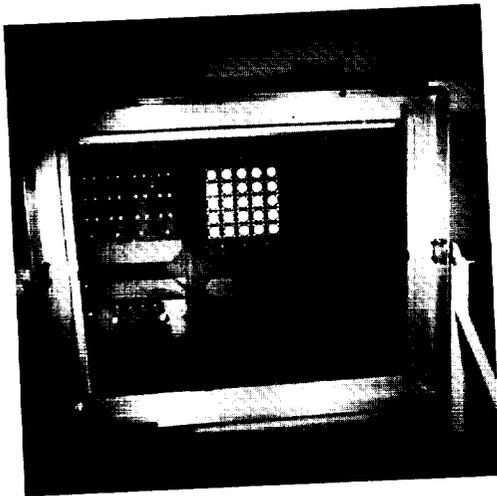
Figure 669
Photo No.: KSC-390C-1545.08
Dup. Neg. No.: L91-9080
LISAR NO.: EL-1994-00710
Photo Credit: KSC
Photo Date: 3/2/90
Location: KSC
Subject: Postflight View of Back of Tray C3

Figure 669 (Postflight). Note the extensive contamination and discoloration. There is the pattern of a diagonal structural member across the back of the tray. There is also a pattern where a wiring harness has been removed from the lower left tray members.

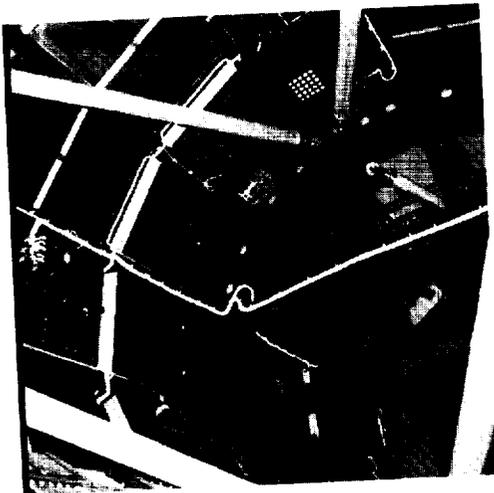
Figure 670
Photo No.: KSC-390C-1481.07
Dup. Neg. No.: L91-15630
LISAR NO.: EL-1994-00049
Photo Credit: KSC
Photo Date: 2/28/90
Location: SAEF II
Subject: Postflight View of LDEF Interior

Figure 670 (Postflight). The interior of the LDEF was essentially black to provide radiative coupling in thermal control of the facility. Note the pattern of discoloration on the back of tray B2 in the top left of the photograph.
